# DOT/FAA/AR-99/4,II

# Longitudinal Acceleration Test of Overhead Luggage Bins and Auxiliary Fuel Tank in a Transport Airplane Airframe Section, Part II

October 2000

Final Report

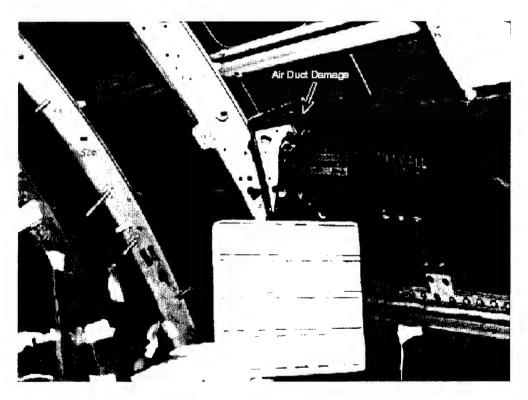
The center of the three support brackets, AL76, was bolted to the air duct and also was attached to the fuselage frame through a link/turnbuckle assembly. The link/turnbuckle assembly was bolted to a flange that bolted to the fuselage frame. After the test, the support bracket remained attached to the bin; however, the support bracket completely separated from the air duct and the flange separated from the fuselage frame. The damage to the air duct can be seen in figure 17. The support bracket is shown in figure 18 and the separated flange and link/turnbuckle assembly can be seen in figure 19.

FIGURE 17. SUPPORT BRACKET AL76 AIR DUCT DAMAGE
